COMPASS INDUSTRIES SUPERFUND SITE

Tulsa County, Oklahoma

ANNUAL OPERATION AND MAINTENANCE REPORT

Public Works
City of Sand Springs
Sand Springs, Oklahoma

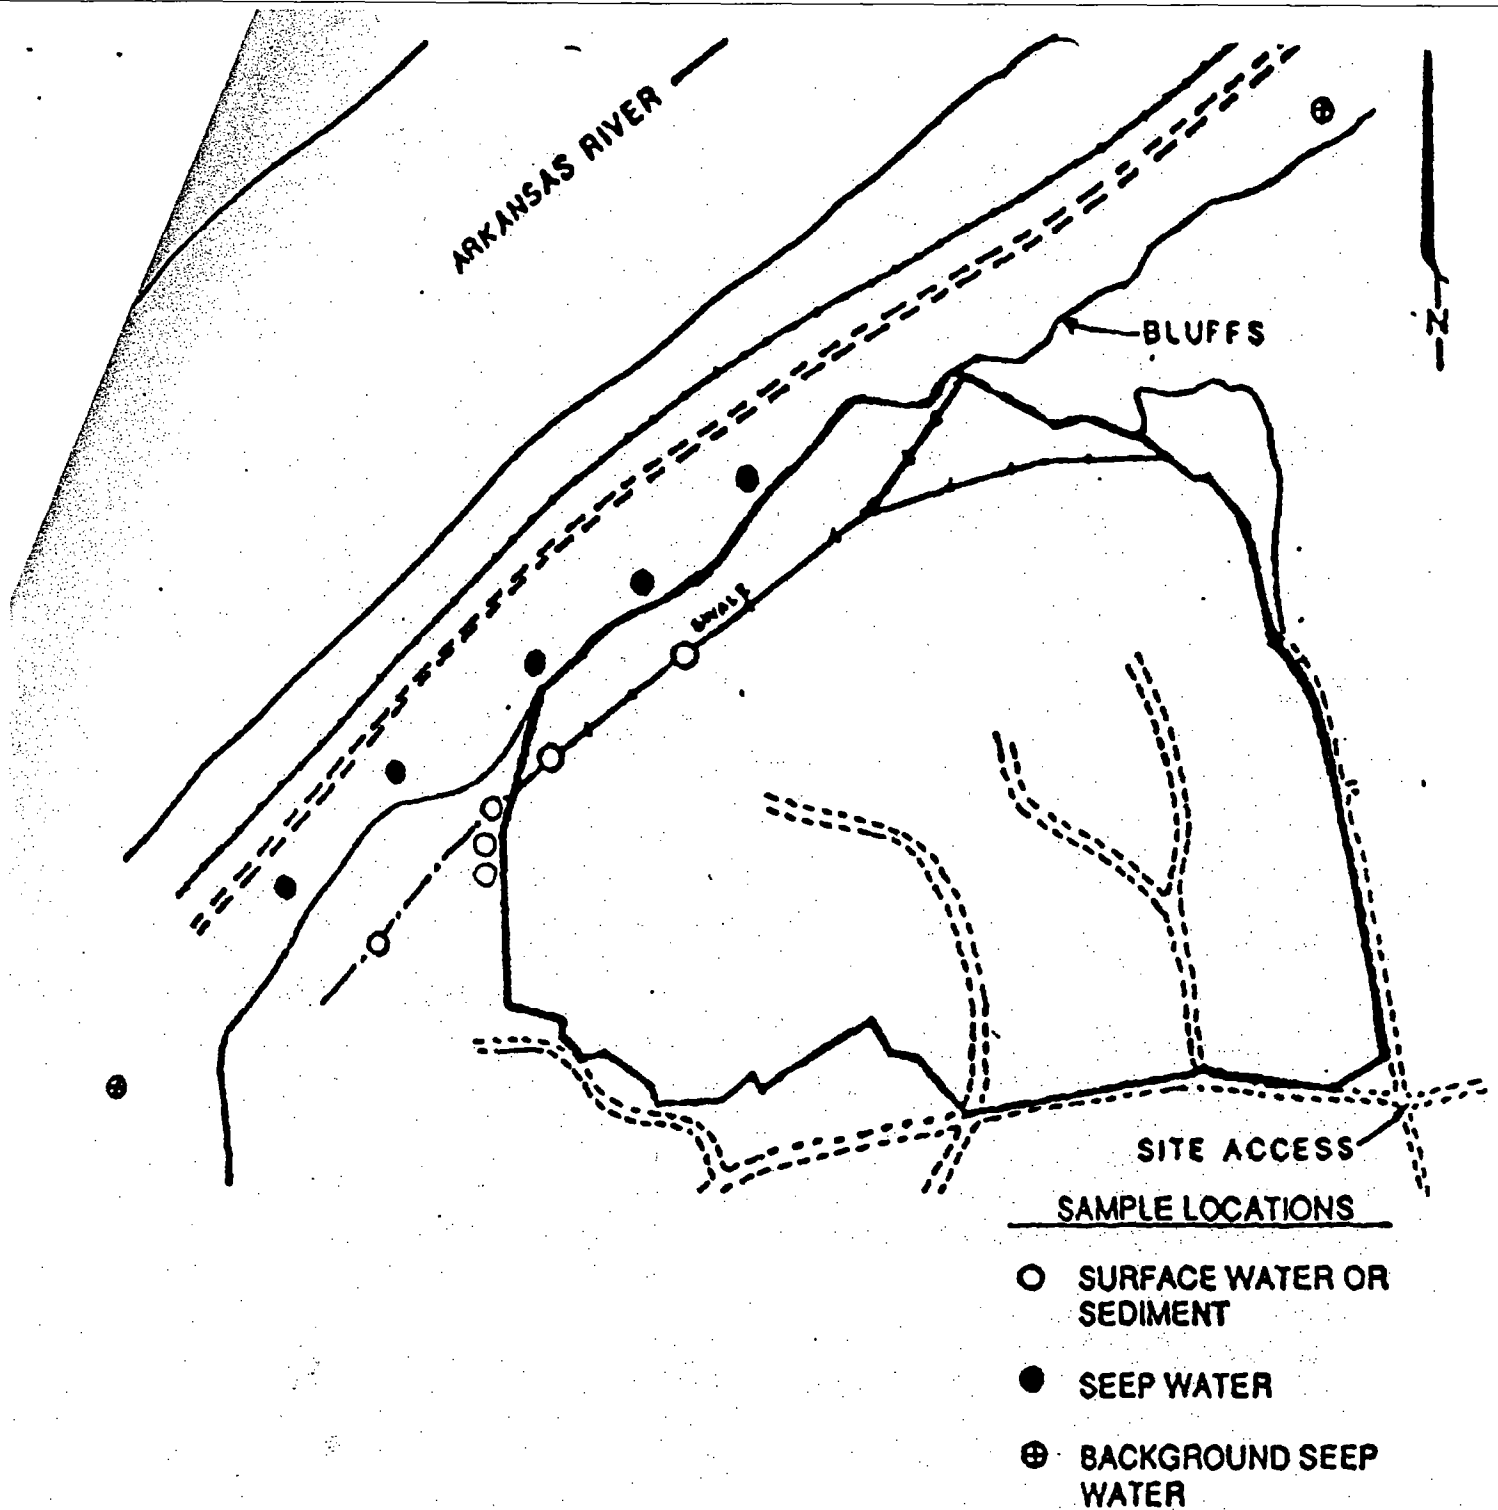
FIGURE 1
SAMPLE PROGRAM LOCATION PLAN

Five sampling sites and two background sites identified in the 2000 Annual Monitoring Report submitted by Stelle & Associates Inc. and shown on attachment (Figure 1) remain the primary area of focus for scheduled sampling. In addition, the sample collection apparatus and methods described in the referenced 2000 Stelle & Associates report will be utilized for sample recording.

The sampling equipment, site locations noted in attachment (Figure 1), and general methods used are described in the 2000 Annual Monitoring Report by Stelle & Associates Inc.
